Table 6-5. Disposal Sites at Camp Lejeune Complex\* (Continued Page 3 of 5)

\* Site Nos. 1-69 and 73-76 are shown on Figure 2-1; Site Nos. 70-72 are shown on Figure 6-36.  
 \*\* Sites recommended for Confirmation Studies.

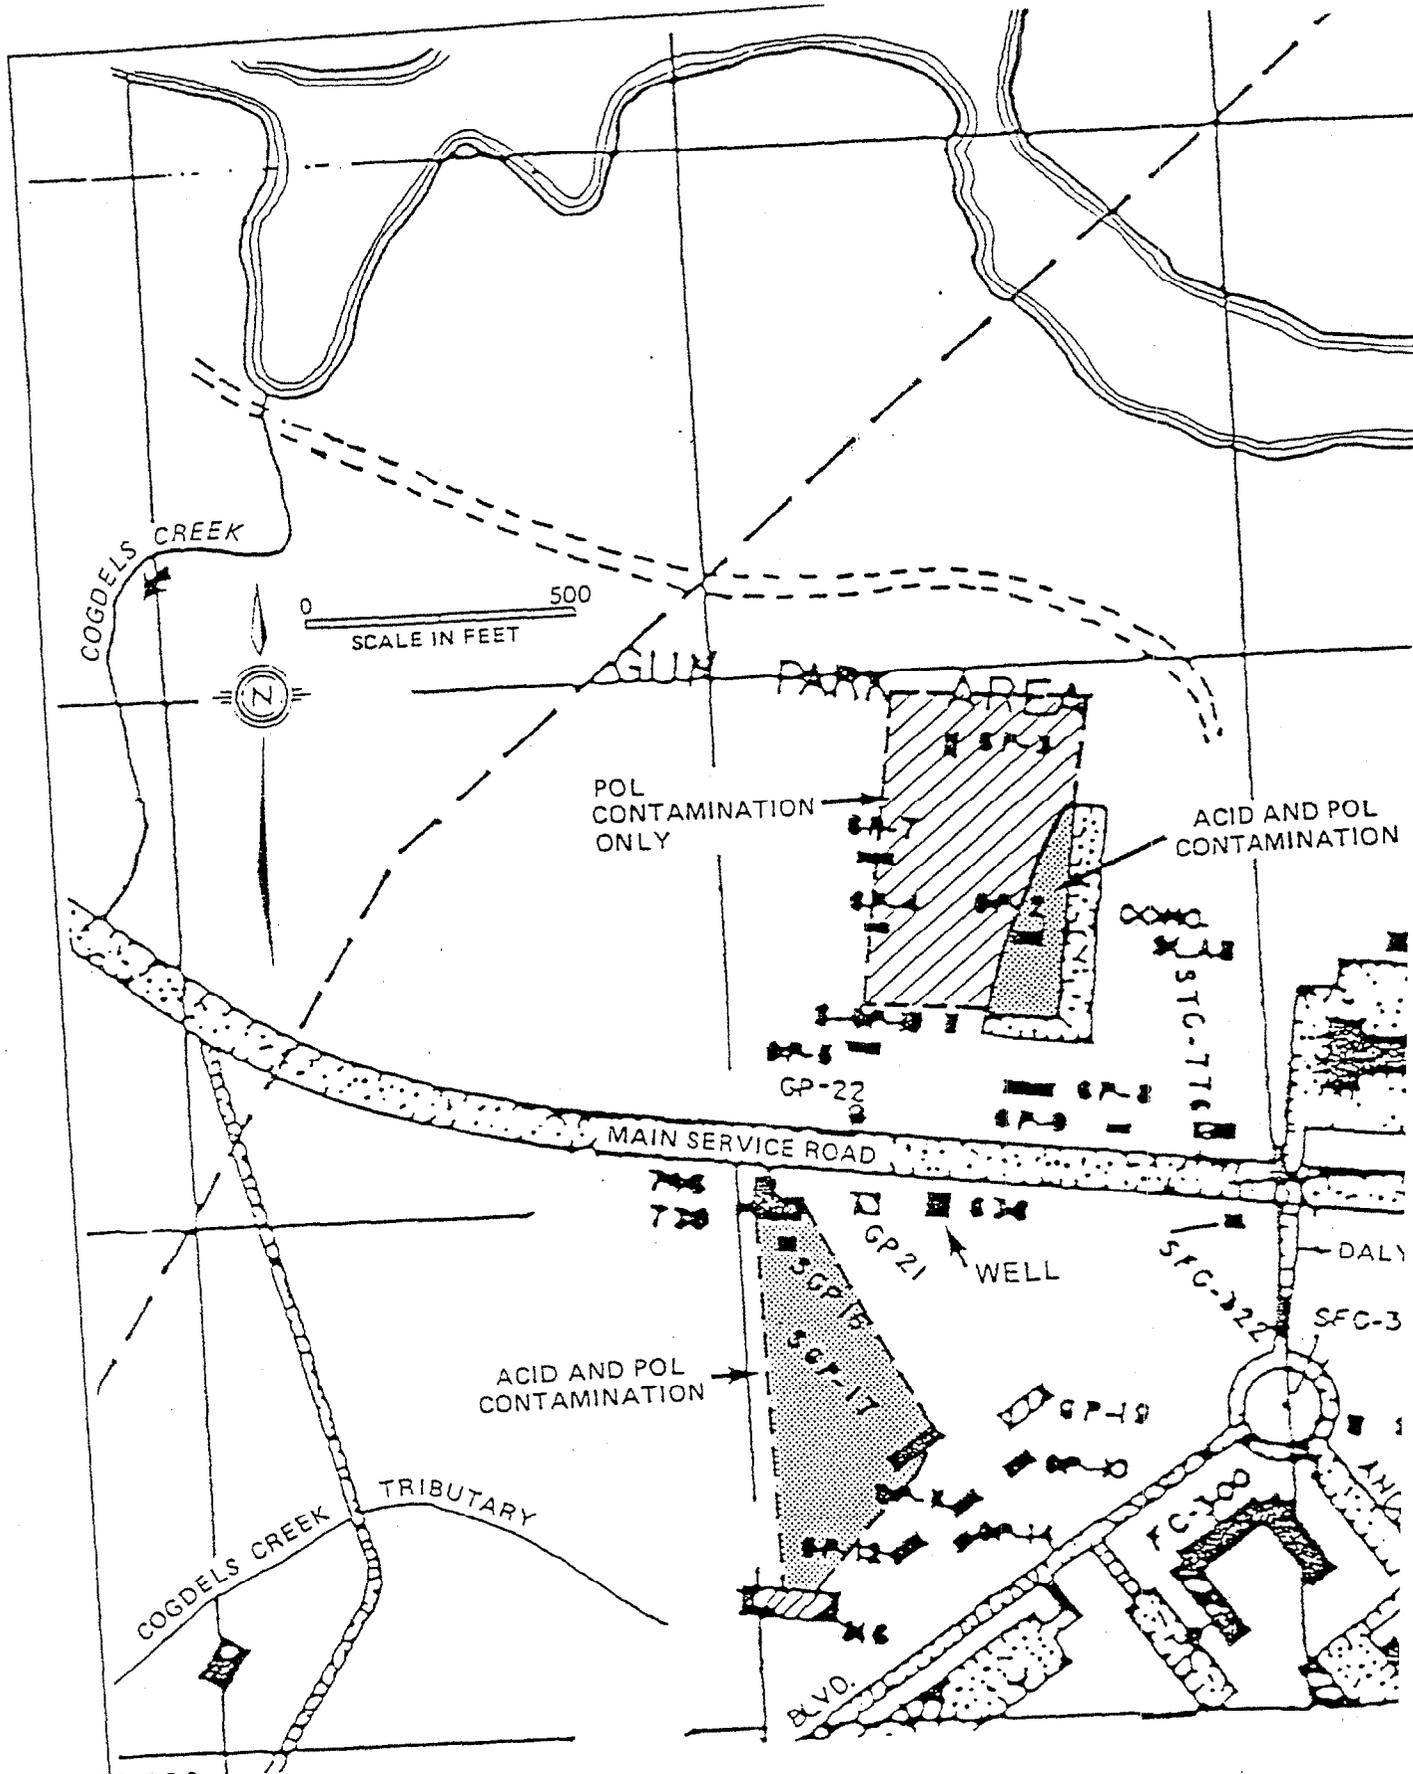
FIGURE 6-2  
Detail of Site No. 1, French Creek Liquids Disposal Area

Activity: These two areas were used for disposal of vehicle fluids.

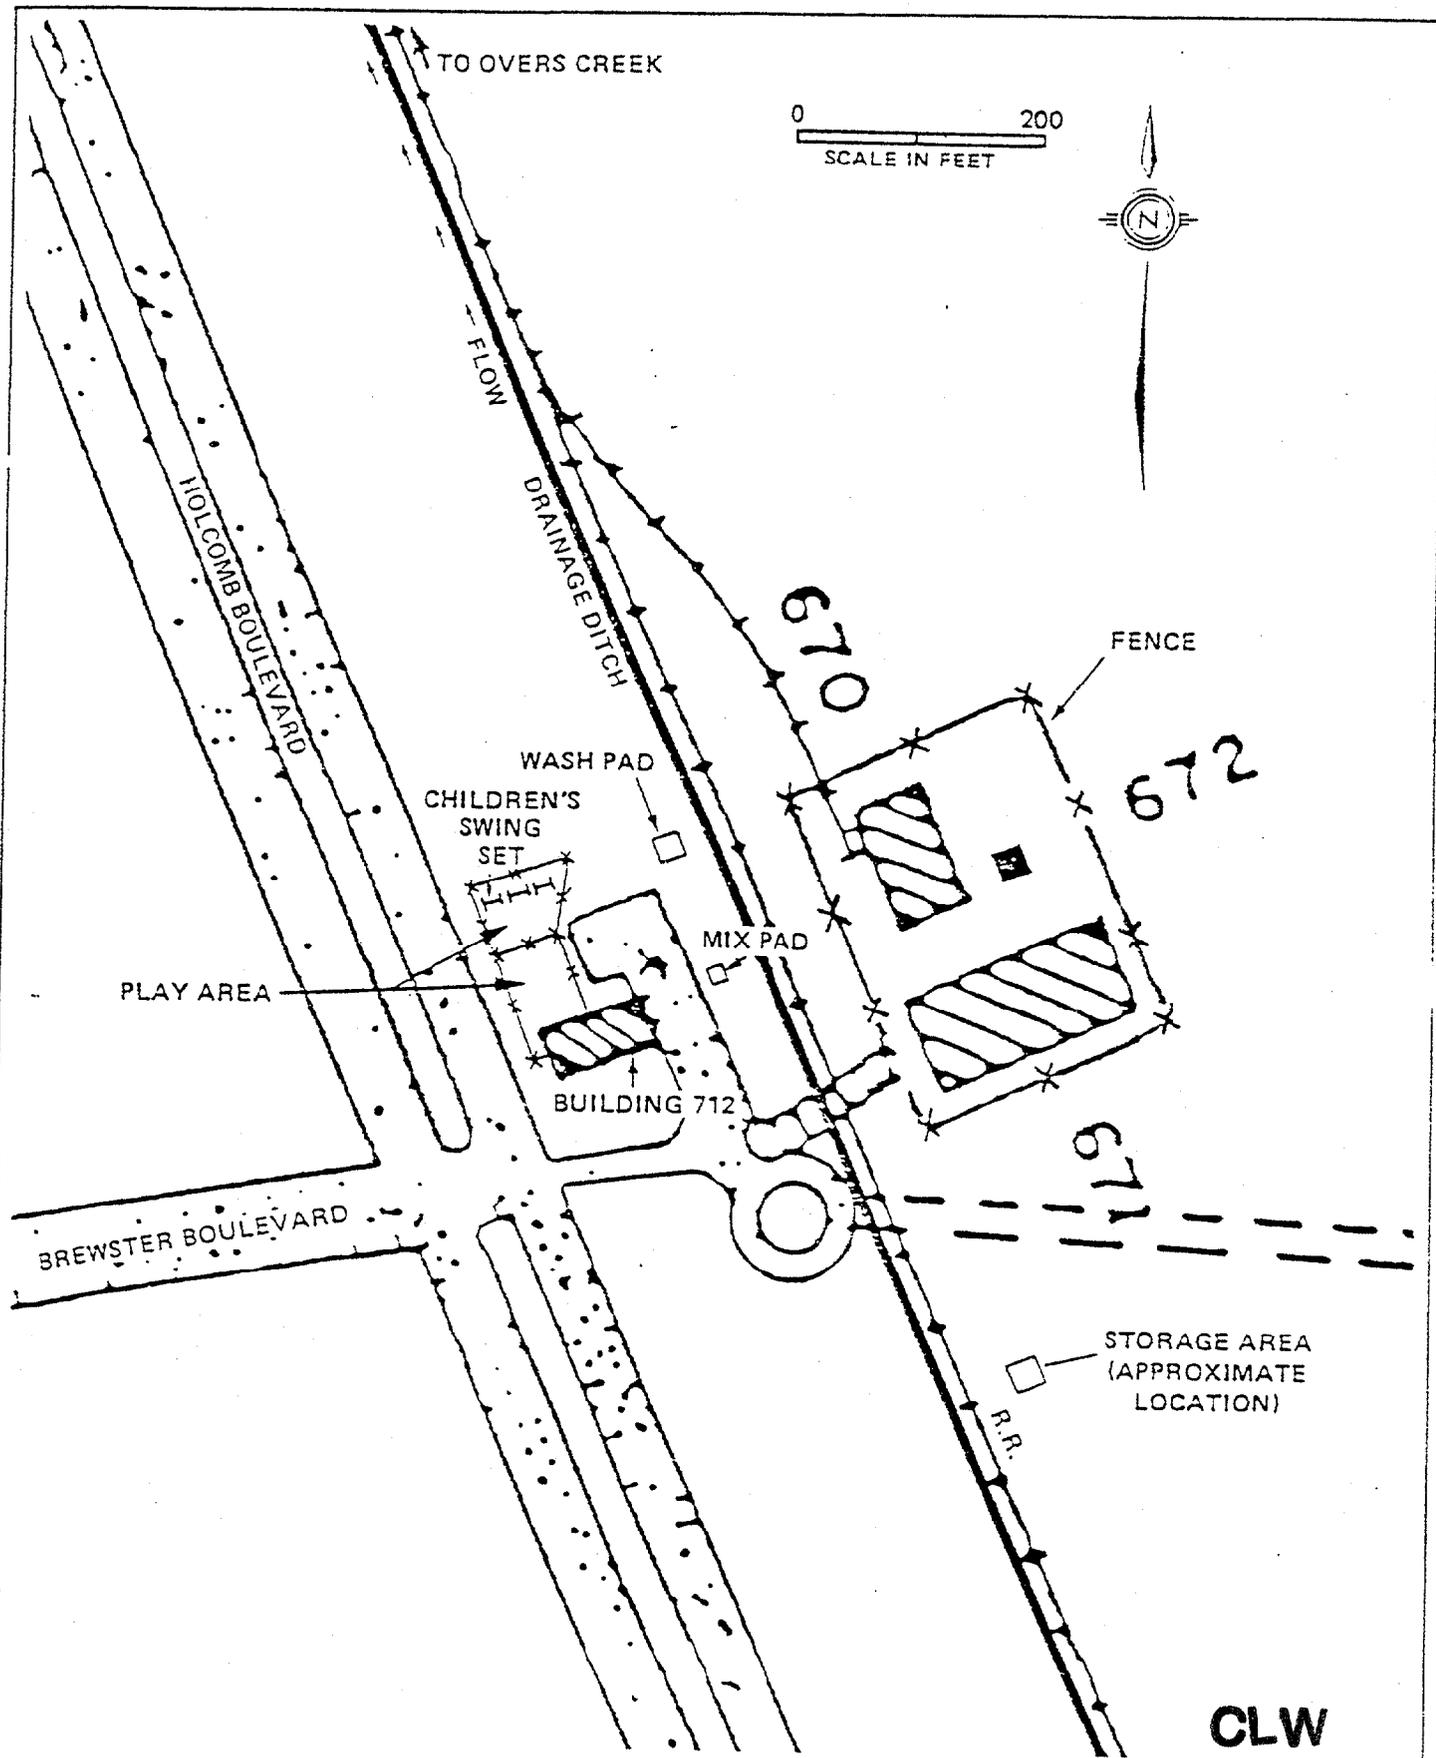
FIGURE 6-4  
 Detail of Site No. 2, Former Nursery/Day Care Center

\* Since the IAS team on-site visit, the Nursery/Day-Care Center has been relocated. Table 2-1 shows soil pesticide levels around Building 712. Sampling locations are indicated on Figure 6-4. More testing **CLW** performed at this site.

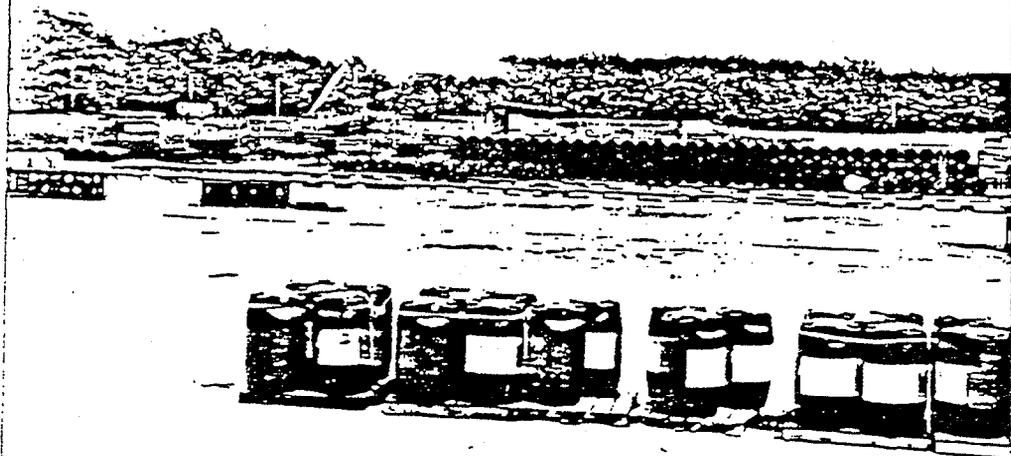
FIGURE 6-8a  
Site No. 6 - Storage Lots 201-203

Activity: The site was and still is used to store hazardous materials. DDT is reported to have been disposed of at Lot 203 when it served as a waste disposal area in the 1940s. There has been long-term storage of DDT and transformers containing PCB. No spills or leaks of PCB have been reported, but reports of white powder (DDT) were noted.

Comments: These areas have a long history of various uses, including disposal and storage. Area is flat, unpaved, and surface soils have been moved about substantially due to regrading and equipment movement. There is no direct physical evidence of hazardous material contamination.

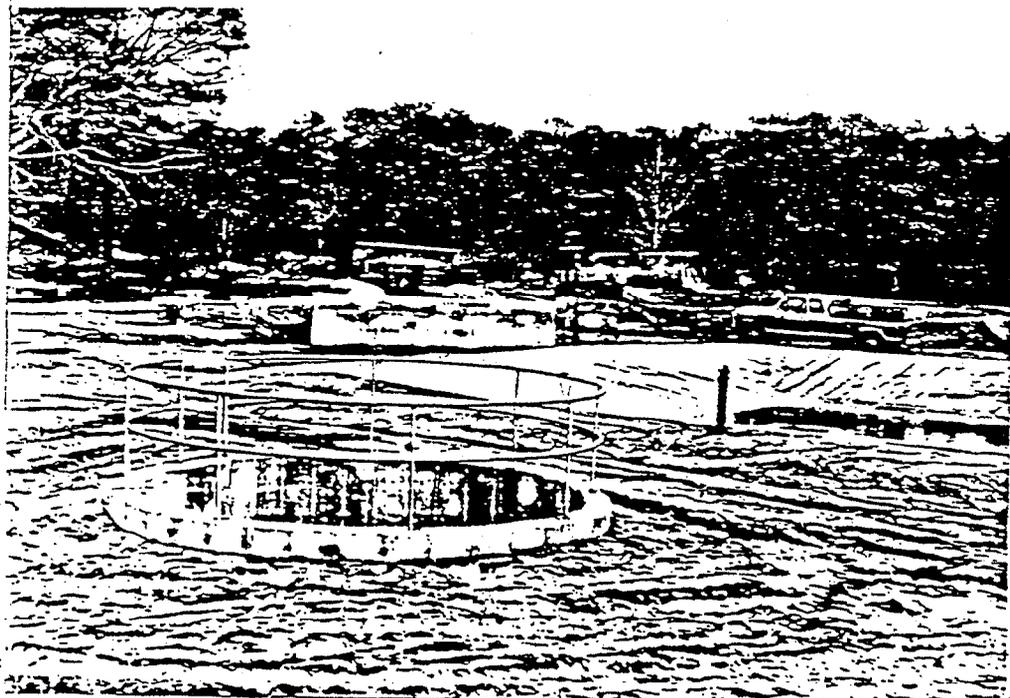
FIGURE 6-8b  
Site No. 9 - Fire Fighting Training Pit near Piney Green Road.  
Oil Water Separation Pit in Foreground

Activity: Fire fighting training carried out in an unlined pit. Flammable liquids burned in pit. No pollution control equipment such as oil-water separators.

Comments: Training began after 1961. The pit was unlined until 1981. No leaded fuels were burned. Pit is presently used and an oil-water separator has been installed.

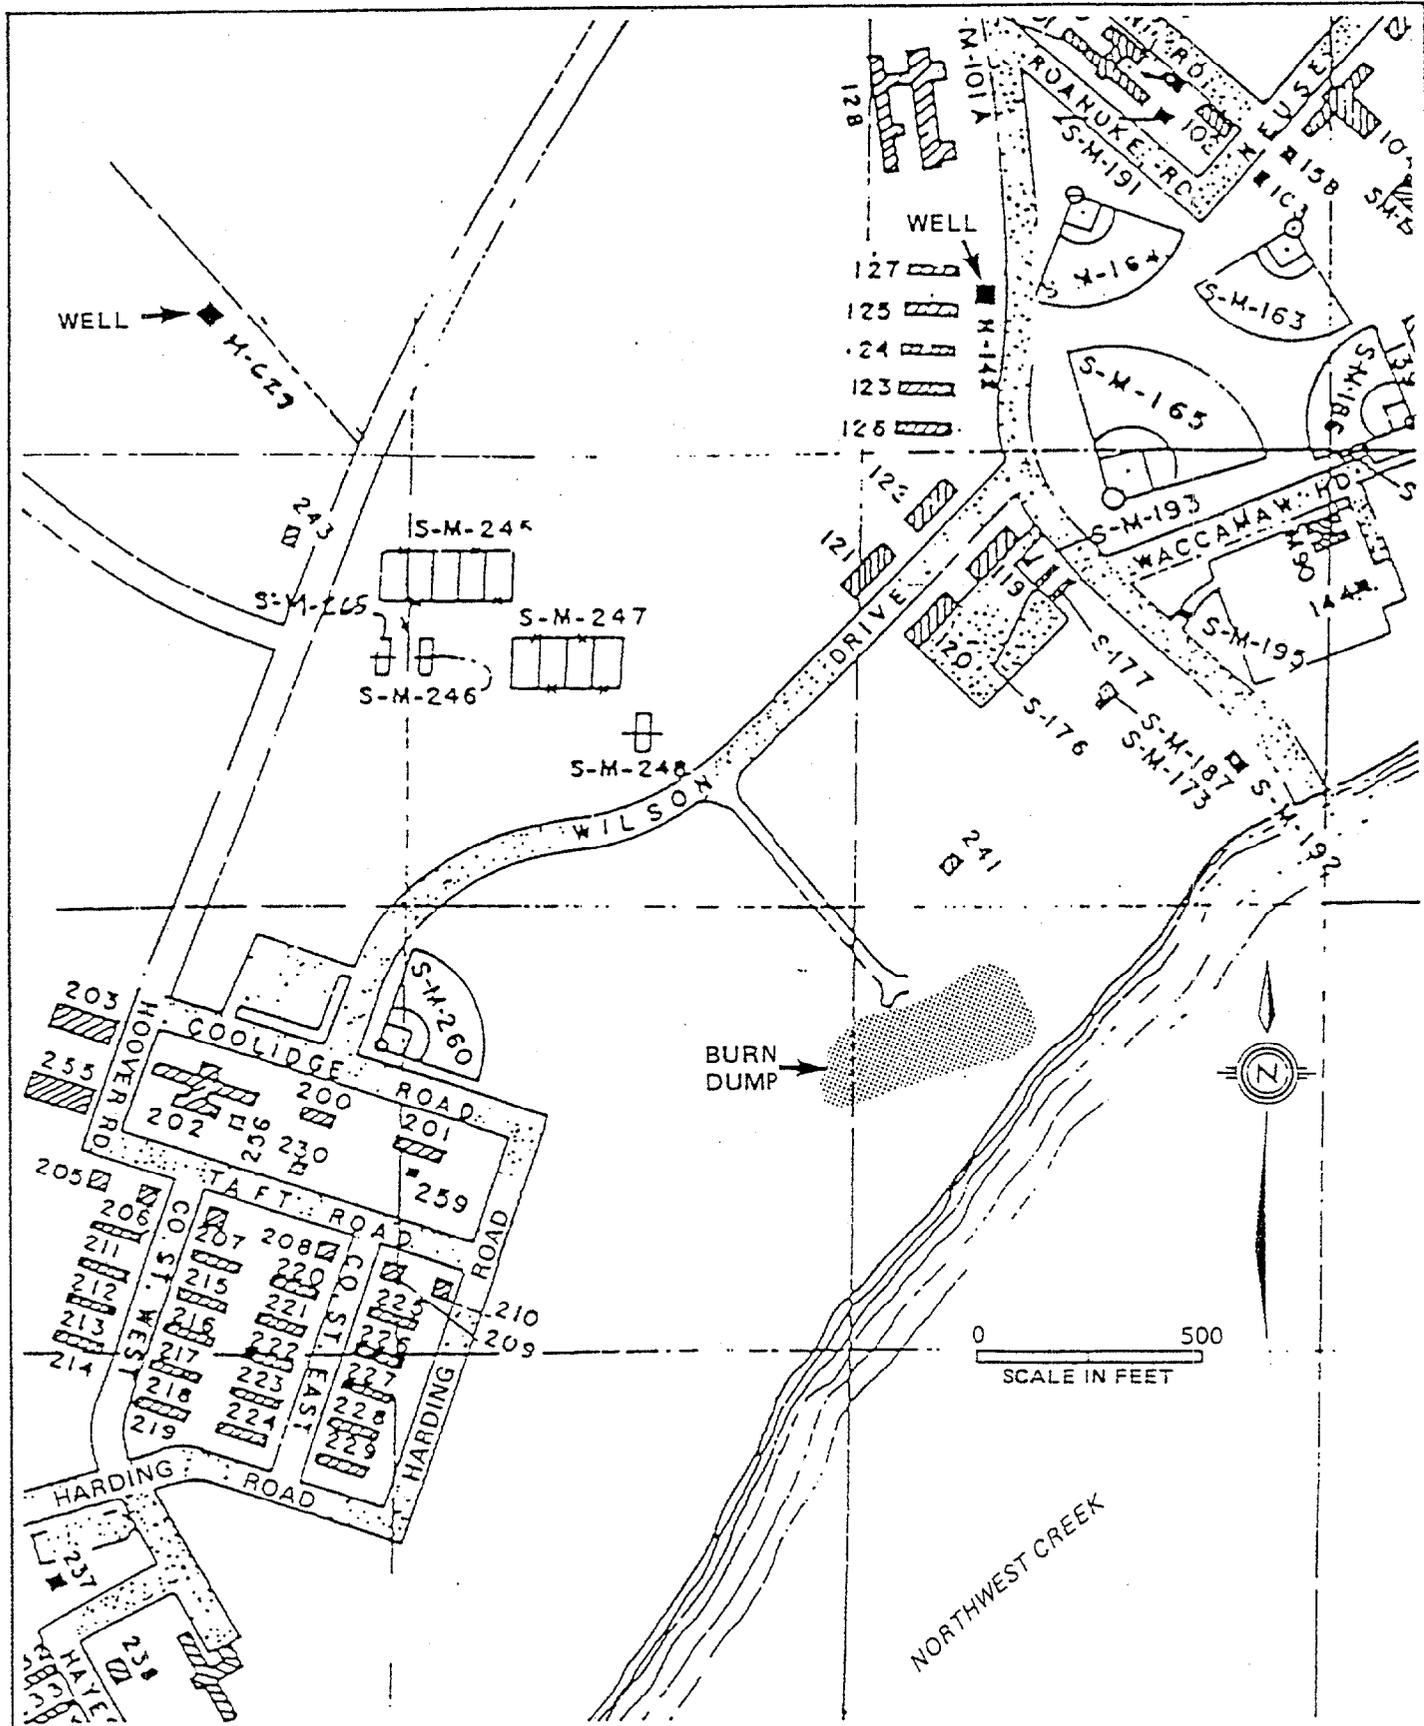
FIGURE 6-9  
 Detail of Site No. 16, Montford Point Burn Dump

Activity: Burn dump for debris, garbage, and minor quantities of oil

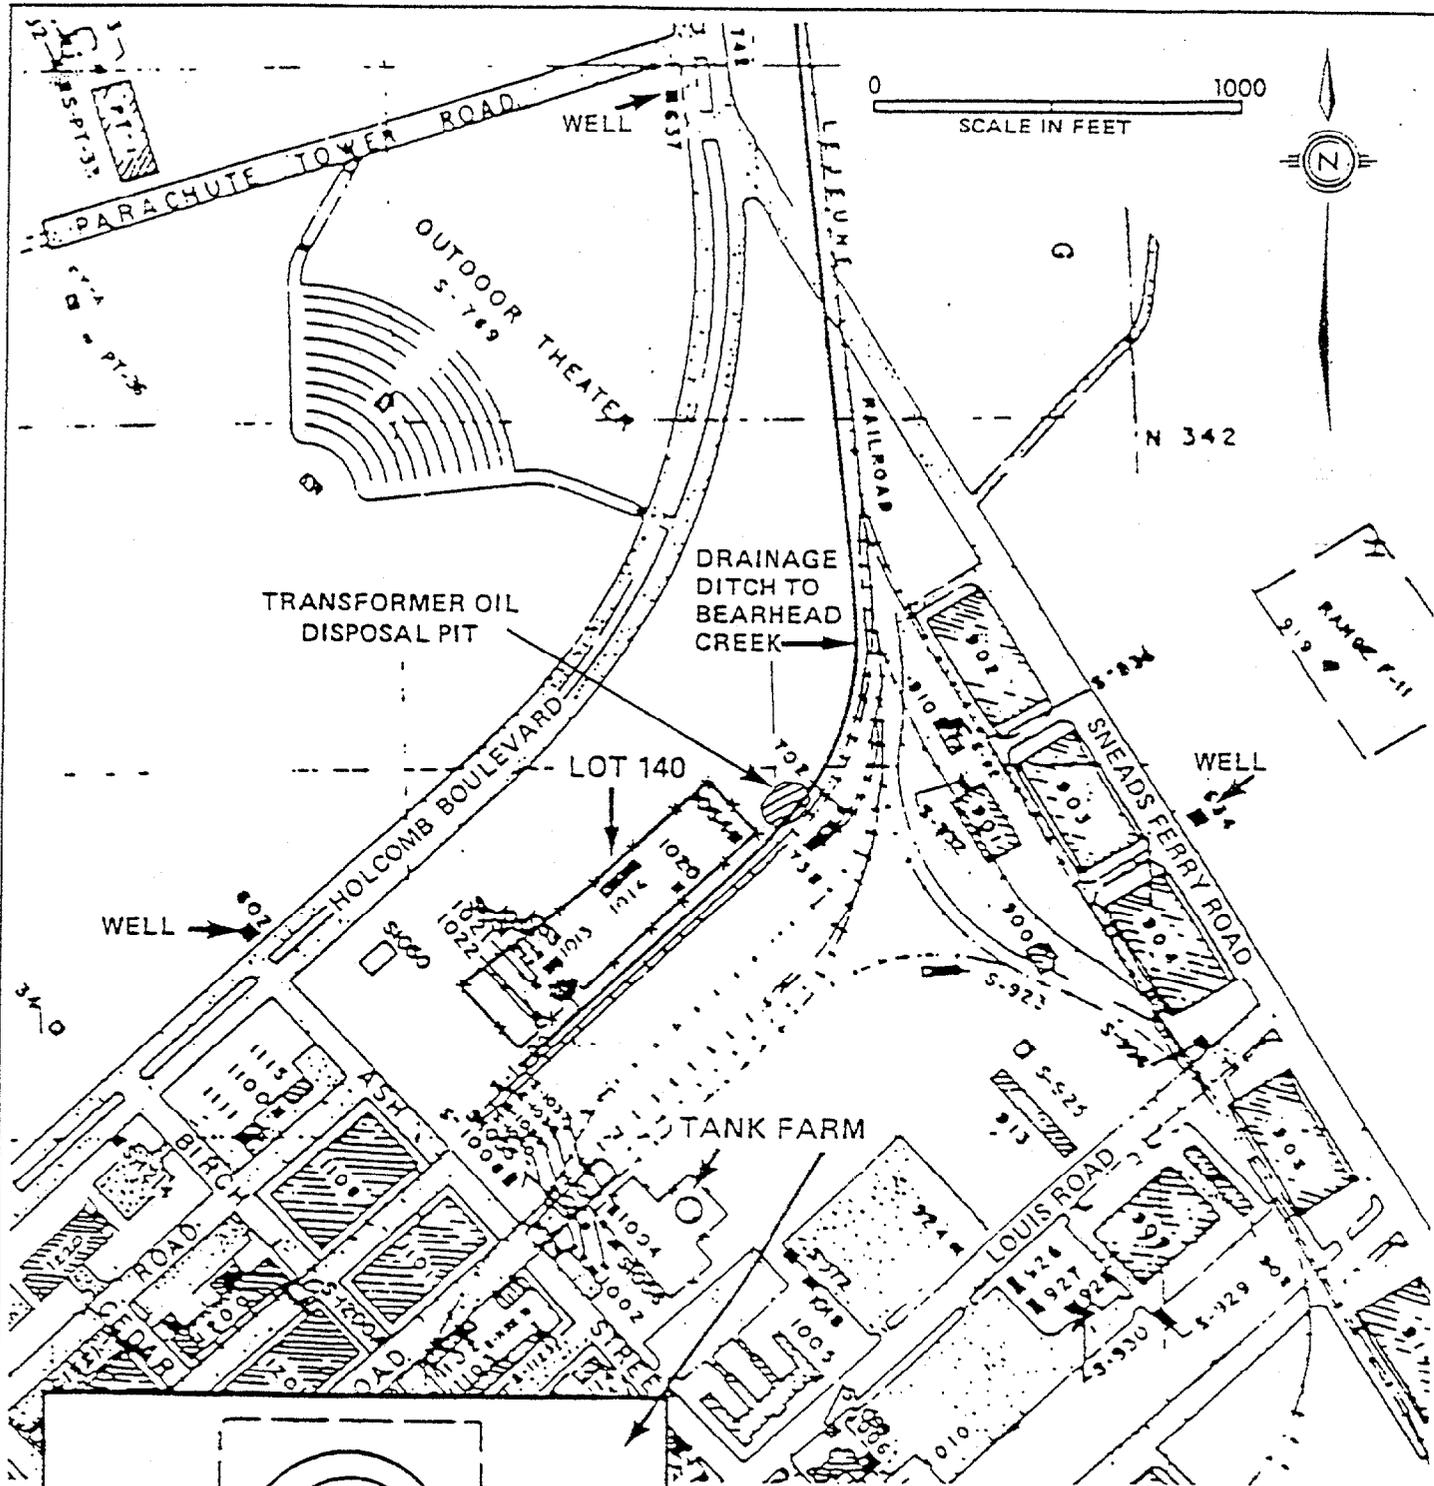
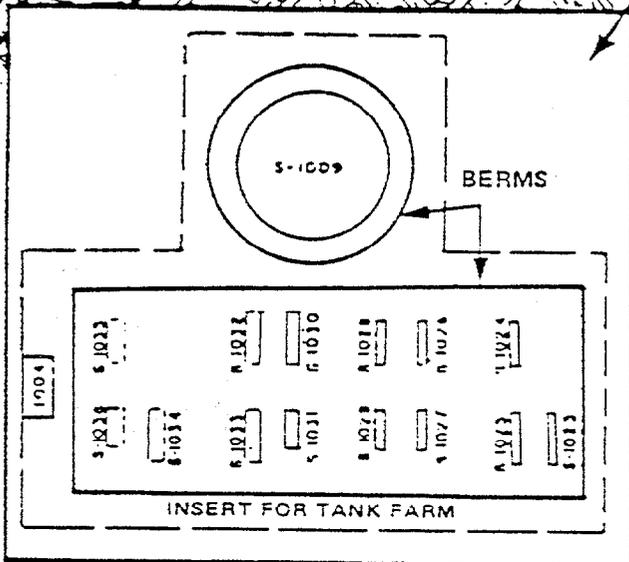
FIGURE 6-12

Transformer oil was drained into pit over about a 1-year period. Sand was occasionally placed in pit by heavy equipment when oil was found standing in pit bottom. The quantity involved is unknown. Assuming the pit received (over 1 year)

According to MC Bul 6280, the upper 4 inches of soil in Lot 140 was sampled for PCBs in October 1980. PCB levels of 1 ppm or less were found. No reference to an oil disposal pit was made in MC Bul 6280.

Details of Sites 21 and 22, Storage Apt 140 with Oil Pit, and Industrial Area Tank Farm, Respectively

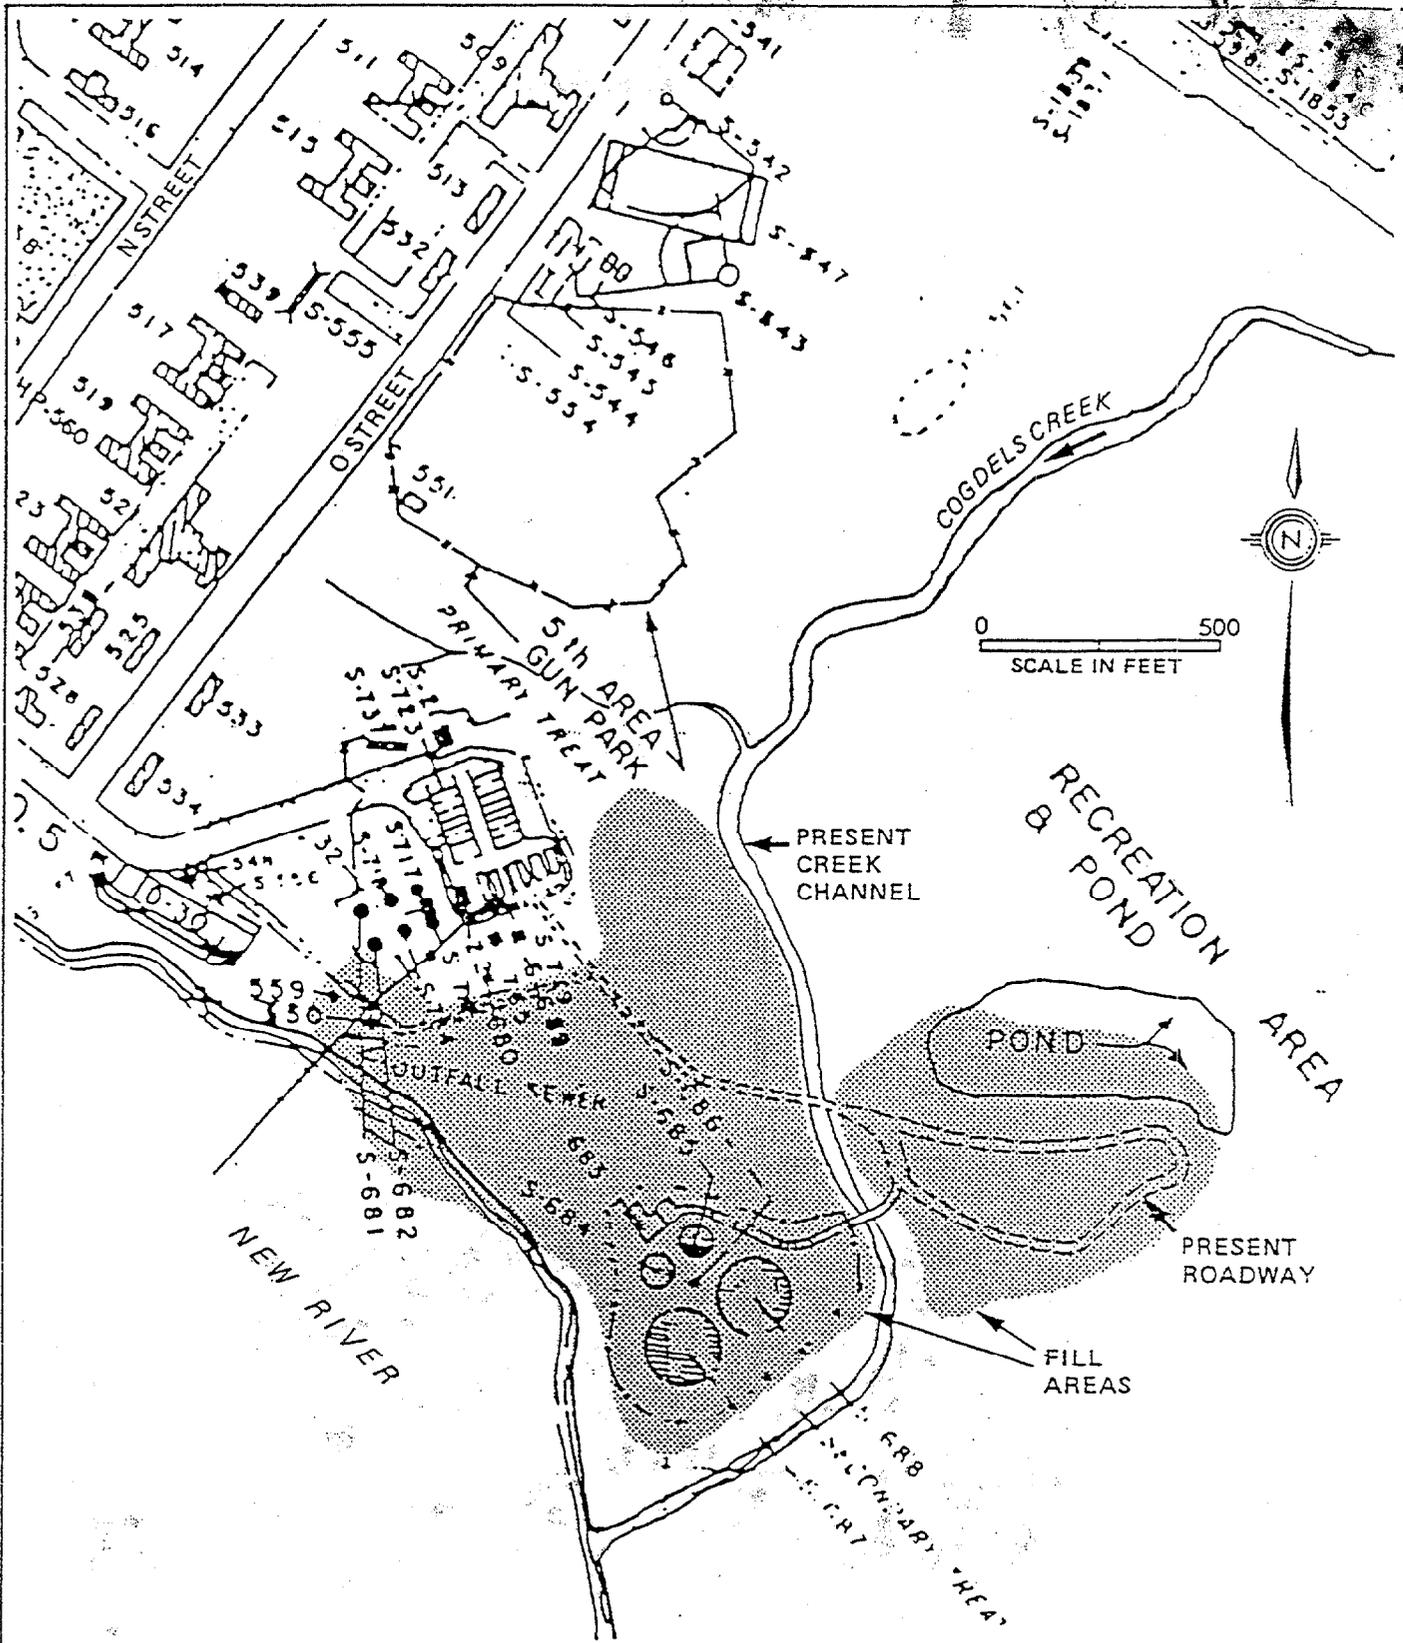
FIGURE 6-15  
 Detail of Site No. 28, Hadnot Point Burn Dump 0000000847

Activity: This large disposal area received a variety of solid waste. The site is now closed. The surface has been graded, grass has been planted and is now a recreational area with fishing pond. When site was active, wastes were burned and covered with dirt.

Quantity: Volume of fill is estimated at 185,000 to 370,000 cubic yards. The volume of waste is based on a surface area of 23 acres and a depth ranging from 5 to 10 feet. Because waste was burned, no approximation of remaining amount of specific substances can be reasonably made. However, approximate size of the site provides order of magnitude guidance.

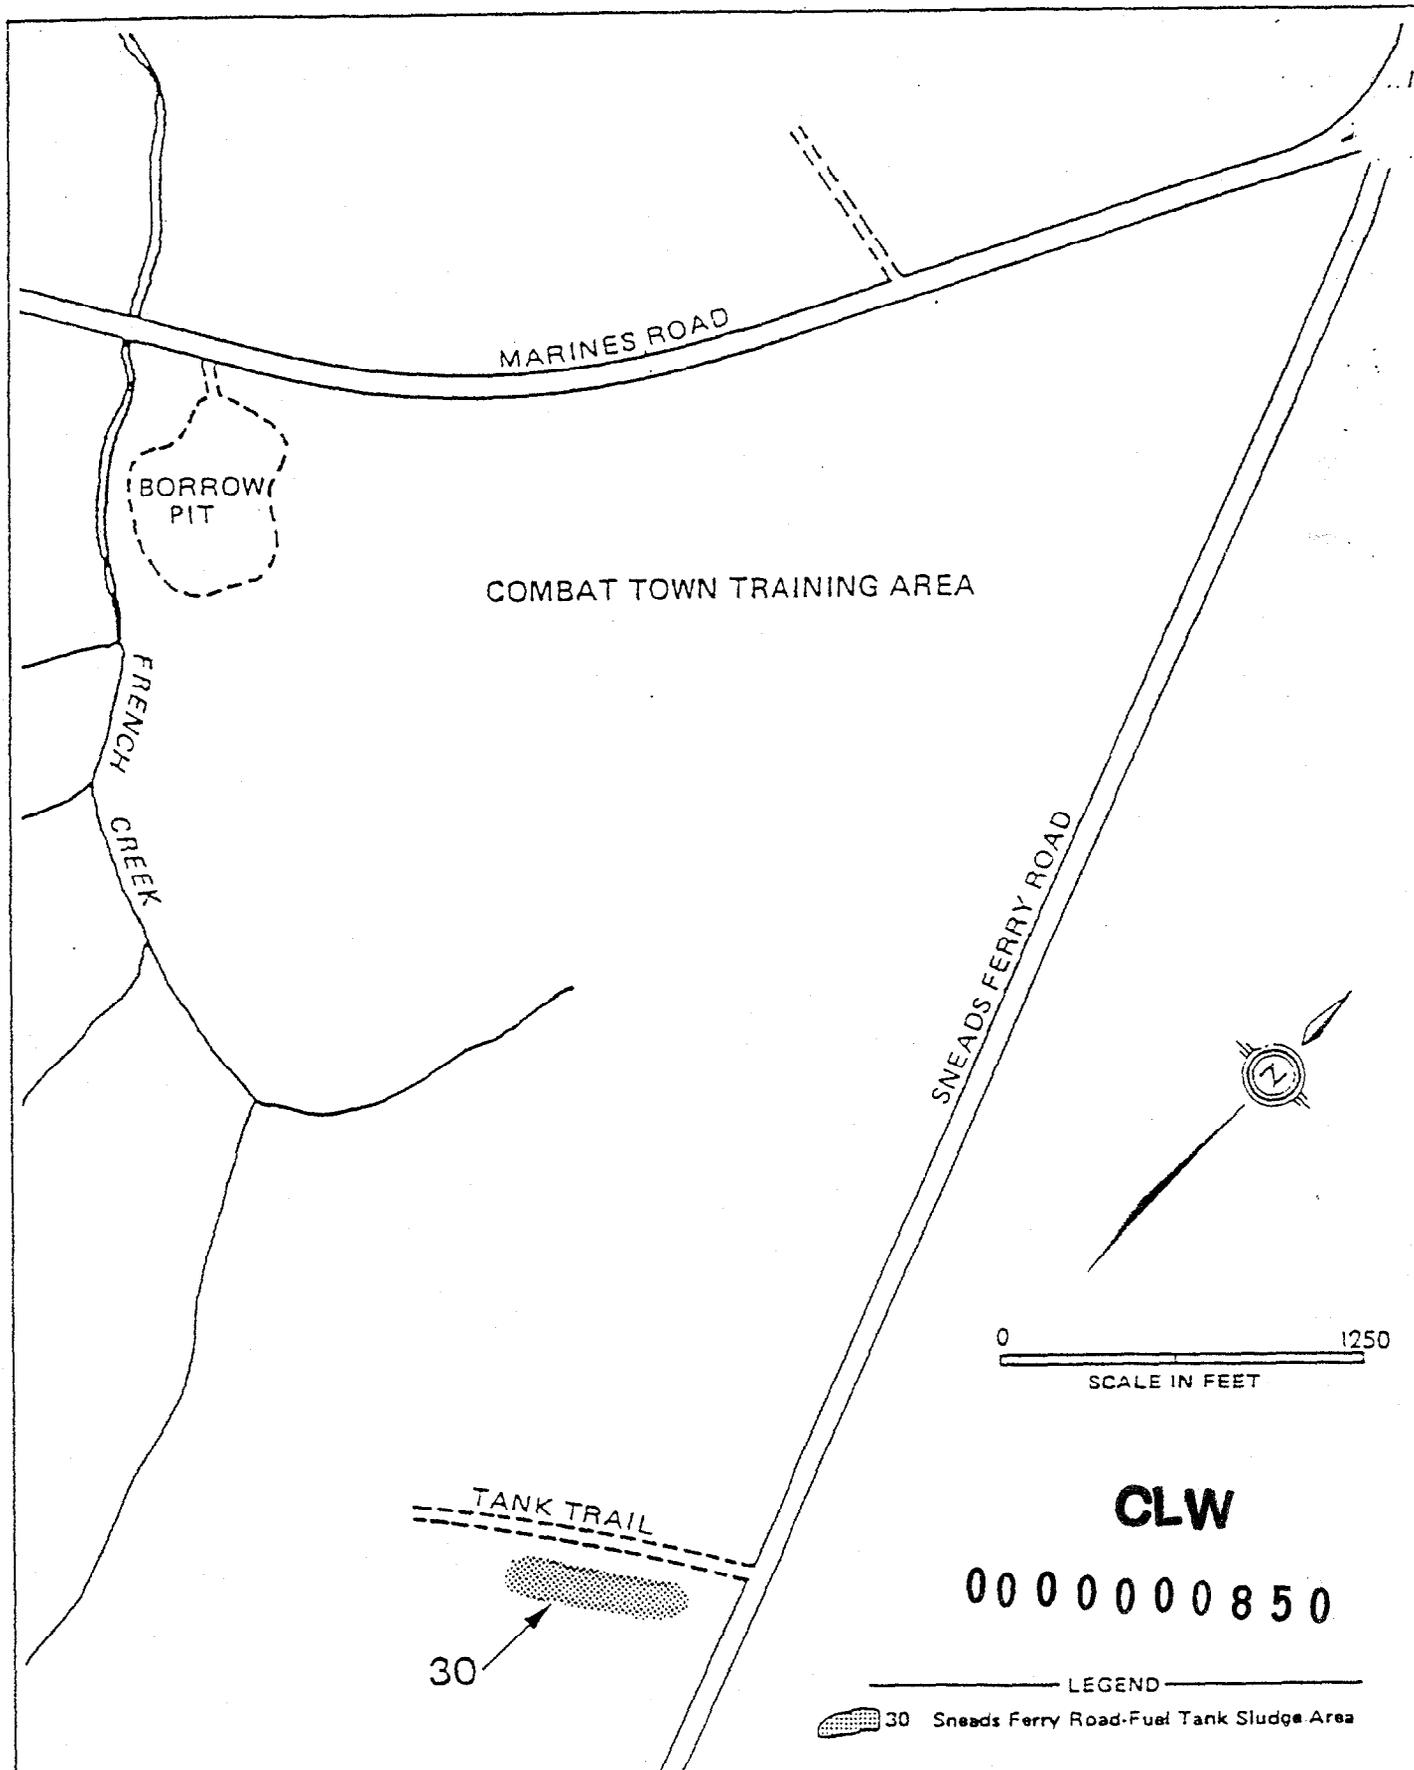
FIGURE 6-17  
 Location of Site No. 30 at Combat Town Training Area

As yet no records (including contract documents) have been found to indicate amount of sludge disposed of at this site. Two 12,000-gallon tanks were involved. Tanks were pumped out while changing the type of fuel stored. Based on knowledge of tank capacity below tank outflow ports, about 600 gallons of sludge or tank bottoms were dumped. Additional washout water may have been present. There is additional information to suggest that the site has been used for similar wastes from other tanks. Therefore the 600 gallon amount must be considered a minimum. Composition of sludge and/or washout is unknown and may vary from containing substantial amounts of tetraethyl lead to containing mostly cleaning compounds.

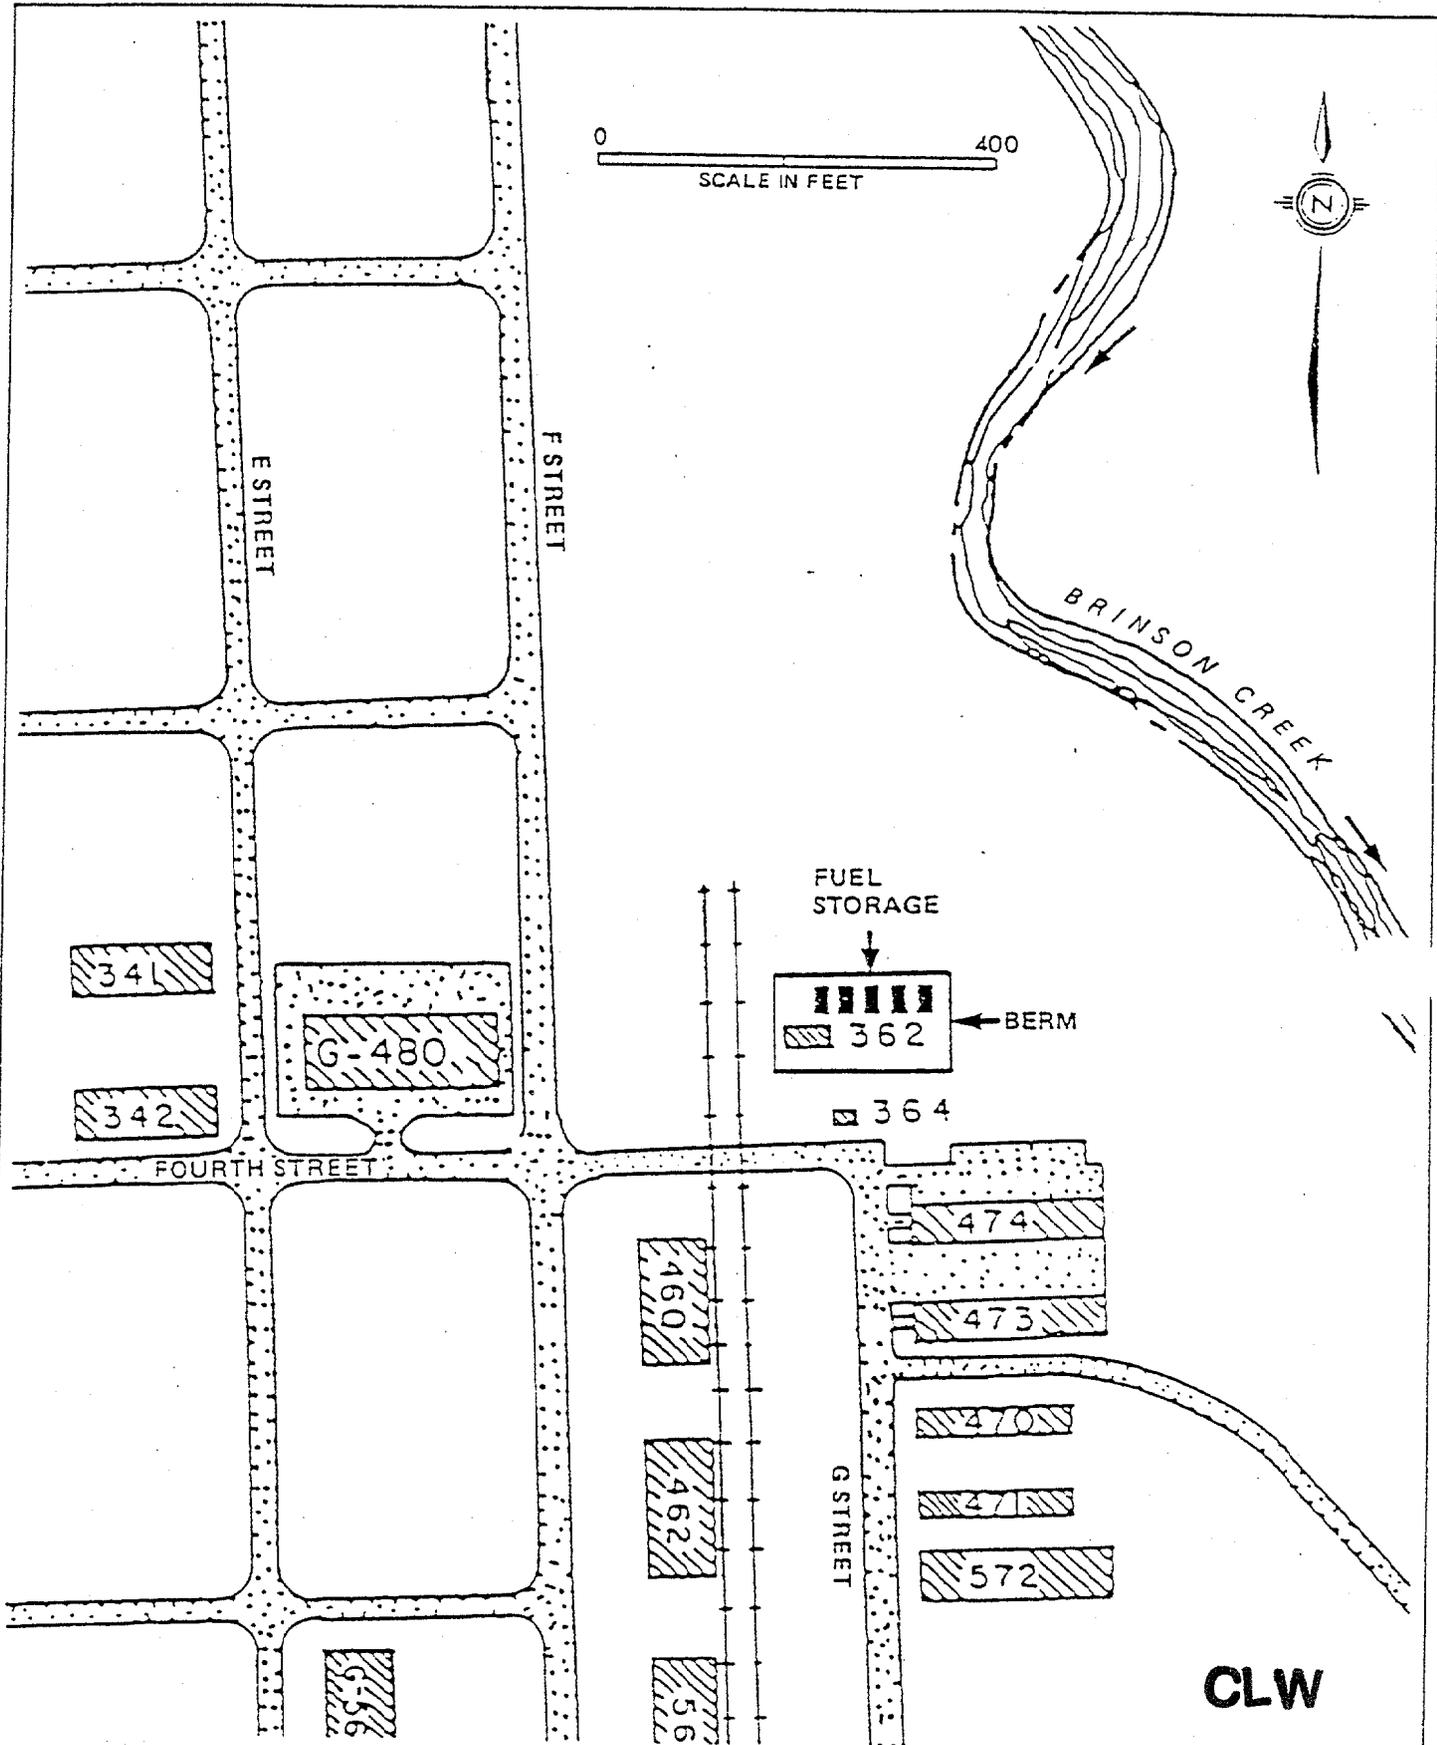
FIGURE 6-18

Activity: Area used for storing and pumping fuel. Mogas released to soil through a leak or leaks in underground line near above-ground storage tank and tank pad.

Comments: Spill reported to have migrated east and northeast toward and into creek. Spilled fuel at the surface of the shallow aquifer was disposed of by digging holes near the leak and igniting the gas. Fuel that contaminated Brinson Creek was also burned off near the leak.

Detail of Site No. 35, Camp Geiger Area Fuel Farm

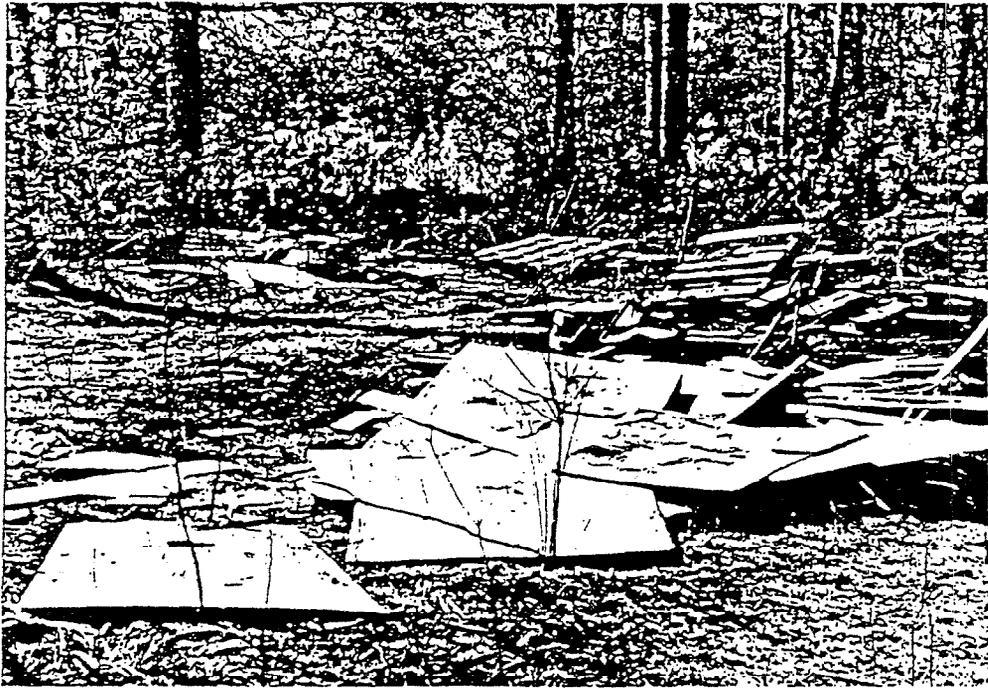
FIGURE 6-23a  
Site No. 41 - Camp Geiger Dump Near the Trailer Park

Comments: Site was operated as a burn dump. Based on an estimated fill depth of 5 feet, total volume of the site is about 110,000 cubic yards.

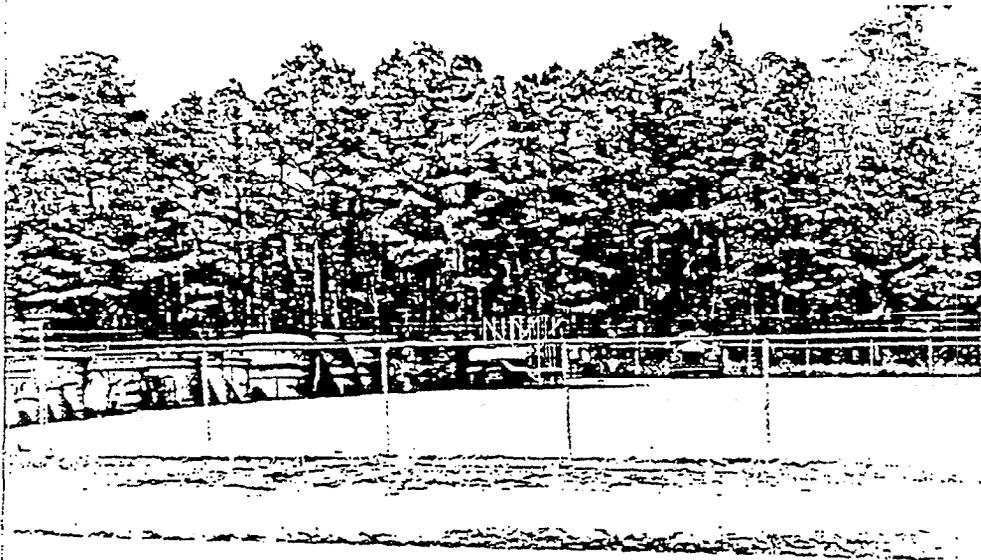
FIGURE 6-23b  
Site No. 45 - Campbell Street Underground Fuel Storage Area

Activity: Underground tank (or tanks) leaked at the fuel storage area during 1978. At the JP Fuel Farm, extensive leakage from underground connecting lines was discovered in about 1981. Southeastern one-third of area (i.e., approximately 2 acres) is generally affected.

Comments: These two storage areas are close together and are considered as one site. Most recent leaks were JP-4 and JP-5 from underground pipes. These pipes have been replaced by an above-ground system in which leaks can be readily detected. An oil-water separator has been installed on the south boundary of the fuel farm, which now shows a substantial amount of oil. Drainage ditch and canal parallel Campbell Street, then flow southward.
